Manhole Inspection Summary

Manhole # S17E1_008MH

Insp Date: **5/14/08 2:48 PM**

Location Address: **2811 maudlin av**

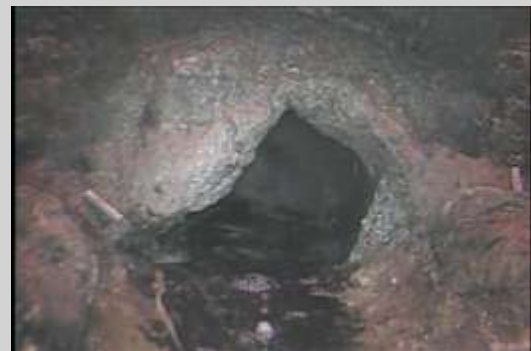
Drop In @ 3 O'Clock

Drop: **Outside** Rod and Bar
Angled: **Yes** Reading: **14.45** (ft.)
Inv Depth: **15.45** (ft.)
Drop Condition: **Open**

Connects To: **Connecting Node Not Available**

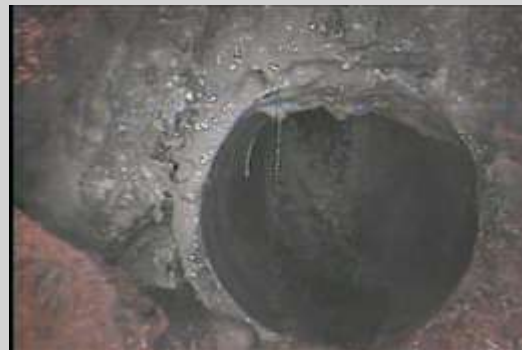
Drop In @ 9 O'Clock

Drop: **Outside** Rod and Bar

Angled: **Yes** Reading: **14.24** (ft.)

Drop Condition: **Open**
